# Design for Safe Repair in a Circular Economy

Authors: Emilia Ingemarsdotter, Martijn Stolk, Ruud Balkenende

Department of Sustainable Design Engineering, Faculty of Industrial Design Engineering, TU Delft

April, 2021

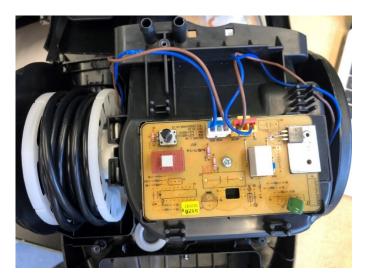
Figure 11: PCB on Samsung SC07M3130V1 in which metal endings cannot be touched, reducing the risk for getting electrified.
